**Flood Control Project Maintenance
Levee Inspections**

Maintenance Issue Types Only, Levee Inspection Report By Mile - Spring 2019

Reclamation District No. 0108 River Farms

Waterway	Bank	Unit Miles	Inspection Start/End	Inspector
Unit No. 01 Colusa Basin Drain	Left	20.64	04/03/2019 04/03/2019	Zach Jojola

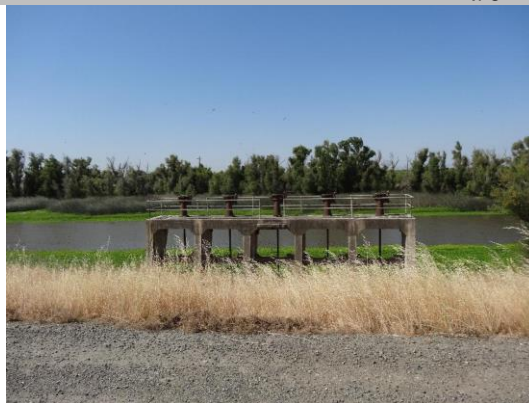
Photo 1 of 3 : UCIP_SP_2019_37608_68207.jpg

Comment Code						
Inspector Comment						
FS_ID:37608 DS_ID:17943 EP_NO: 9396 Repair Type: Non-Urgent Crossing Status: Found UCIP Comments: Need to contact owner to determine status of structure. Notes indicate crossing has been abandoned. Owner will need to coordinate with CVFPB and DWR inspector to determine how to properly abandon. FIELD_STRUCT_DESC: *ABANDONED* 1 of 5: 72-inch reinforced concrete gravity drainage pipe or culvert through the levee, 31.6 feet below the crown. Slide gate on each end. (Retention of five 72-inch pipes through the levee [HLM 0.08] authorized under Automatic Board Order (ABO) issued as Permit No. 9736, 1974 - Reclamation District No. 108 [RD0108]). [Additional Reference(s): DWR Levee Log, 1991. USACE Sacramento O&M Manual 132, October 1959, (HLM 0.08), referenced as five 6-foot by 8-foot concrete drainage culverts]. FS Date: 6/10/2014

View of concrete structure visible on waterward side.

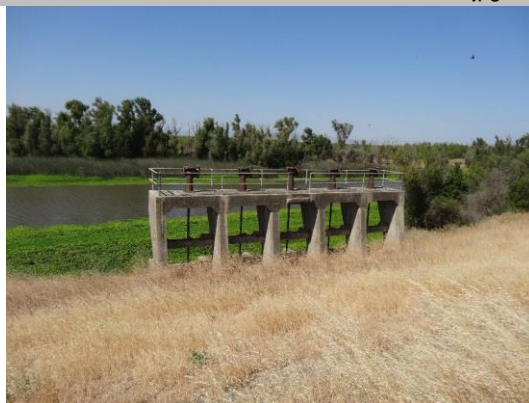
Photo 2 of 3 : UCIP_SP_2019_37608_68210.jpg

Dense vegetation on waterward side.

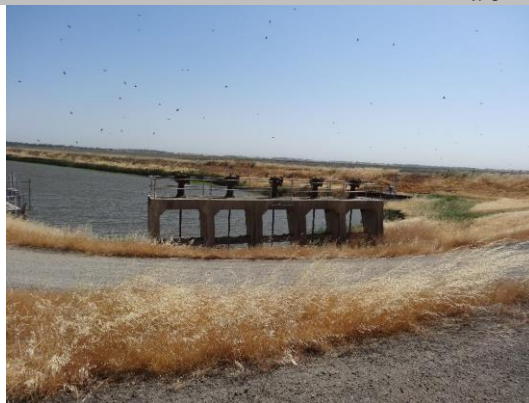
Photo 3 of 3 : UCIP_SP_2019_37608_68208.jpg

View of concrete structure visible on landward side.

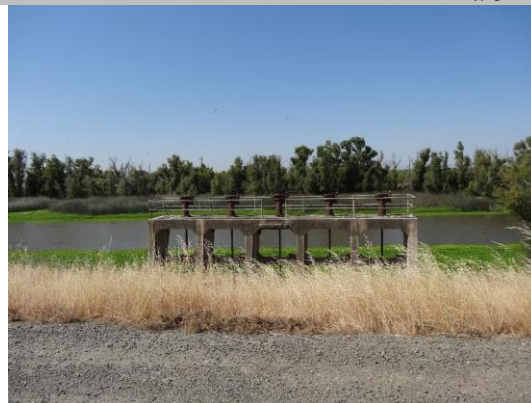
Photo 1 of 3 : UCIP_SP_2019_37609_68211.jpg

Comment Code						
Inspector Comment						
FS_ID:37609 DS_ID:22386 EP_NO: 9396 Repair Type: Non-Urgent Crossing Status: Found UCIP Comments: Need to contact owner to determine status of structure. Notes indicate crossing has been abandoned. Owner will need to coordinate with CVFPB and DWR inspector to determine how to properly abandon. FIELD_STRUCT_DESC: *ABANDONED* 2 of 5: 72-inch reinforced concrete gravity drainage pipe or culvert through the levee, 31.6 feet below the crown. Slide gate on each end. (Retention of five 72-inch pipes through the levee [HLM 0.08] authorized under Automatic Board Order (ABO) issued as Permit No. 9736, 1974 - Reclamation District No. 108 [RD0108]). [Additional Reference(s): DWR Levee Log, 1991. USACE Sacramento O&M Manual 132, October 1959, (HLM 0.08), referenced as five 6-foot by 8-foot concrete drainage culverts]. FS Date: 6/10/2014

Concrete structure located on waterward side.

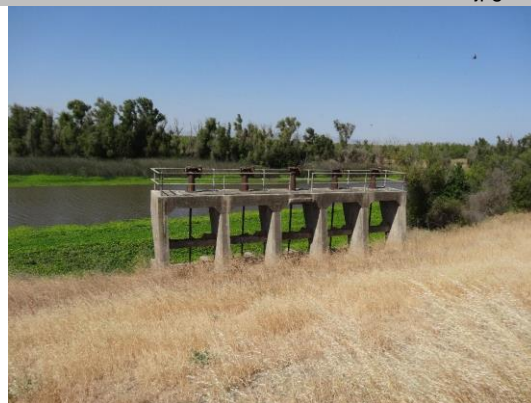
Photo 2 of 3 : UCIP_SP_2019_37609_68215.jpg

Dense vegetation covers the waterward slope.

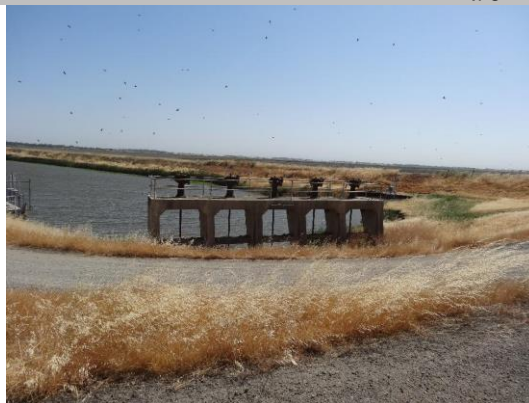
Photo 3 of 3 : UCIP_SP_2019_37609_68213.jpg

View of concrete structure located on landward side.

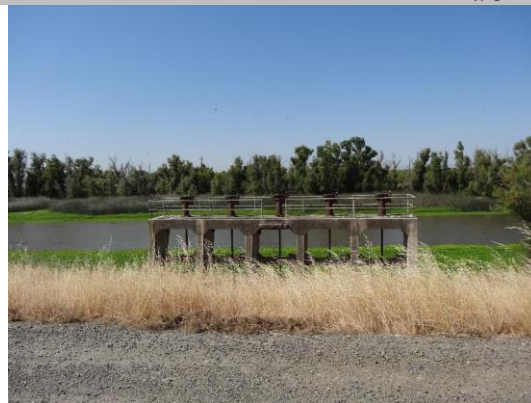
Photo 1 of 3 : UCIP_SP_2019_37610_68216.jpg

Comment Code						
Inspector Comment						
FS_ID:37610 DS_ID:22387 EP_NO: 9396 Repair Type: Non-Urgent Crossing Status: Found UCIP Comments: Need to contact owner to determine status of structure. Notes indicate crossing has been abandoned. Owner will need to coordinate with CVFPB and DWR inspector to determine how to properly abandon. FIELD_STRUCT_DESC: *ABANDONED* 3 of 5: 72-inch reinforced concrete gravity drainage pipe or culvert through the levee, 31.6 feet below the crown. Slide gate on each end. (Retention of five 72-inch pipes through the levee [HLM 0.08] authorized under Automatic Board Order (ABO) issued as Permit No. 9736, 1974 - Reclamation District No. 108 [RD0108]). [Additional Reference(s): DWR Levee Log, 1991. USACE Sacramento O&M Manual 132, October 1959, (HLM 0.08), referenced as five 6-foot by 8-foot concrete drainage culverts]. FS Date: 6/10/2014

Concrete structure located on waterward side.

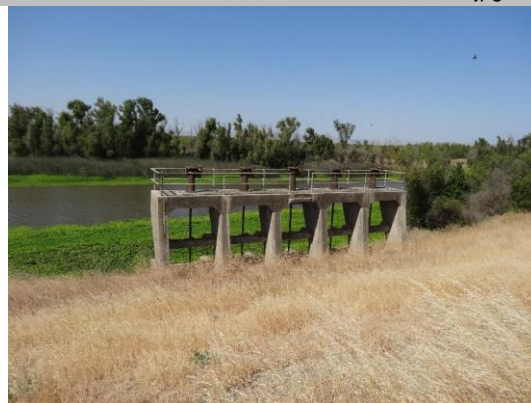
Photo 2 of 3 : UCIP_SP_2019_37610_68219.jpg

Dense vegetation covers waterward side slope.

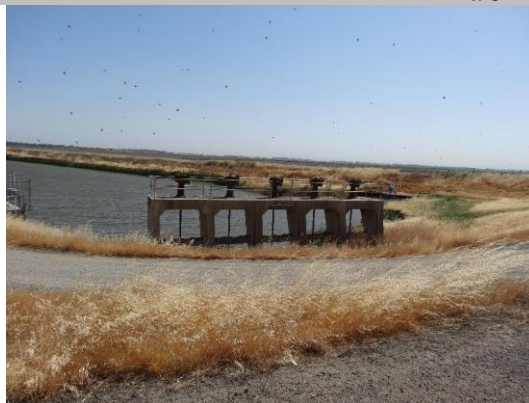
Photo 3 of 3 : UCIP_SP_2019_37610_68217.jpg

Concrete structure located on landward side.

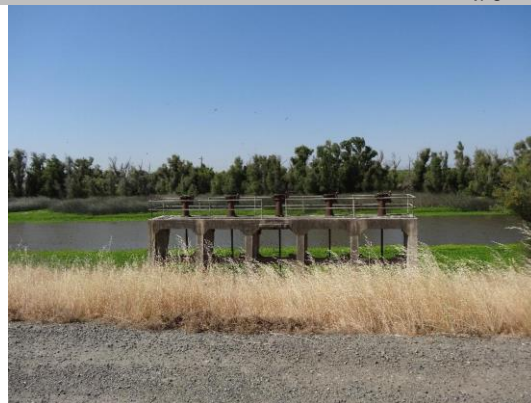
Photo 1 of 3 : UCIP_SP_2019_37611_68220.jpg

Comment Code					
Inspector Comment					
FS_ID:37611 DS_ID:22388 EP_NO: 9396 Repair Type: Non-Urgent Crossing Status: Found UCIP Comments: Need to contact owner to determine status of structure. Notes indicate crossing has been abandoned. Owner will need to coordinate with CVFPB and DWR inspector to determine how to properly abandon. FIELD_STRUCT_DESC: *ABANDONED* 4 of 5: 72-inch reinforced concrete gravity drainage pipe or culvert through the levee, 31.6 feet below the crown. Slide gate on each end. (Retention of five 72-inch pipes through the levee [HLM 0.08] authorized under Automatic Board Order (ABO) issued as Permit No. 9736, 1974 - Reclamation District No. 108 [RD0108]). [Additional Reference(s): DWR Levee Log, 1991. USACE Sacramento O&M Manual 132, October 1959, (HLM 0.08), referenced as five 6-foot by 8-foot concrete drainage culverts]. FS Date: 6/10/2014

Concrete structure located on waterward side.

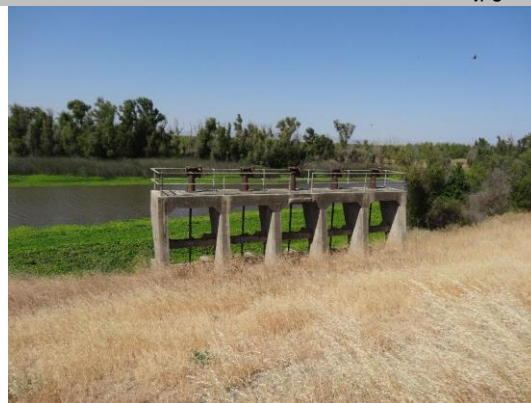
Photo 2 of 3 : UCIP_SP_2019_37611_68224.jpg

Waterward slope covered by dense vegetation.

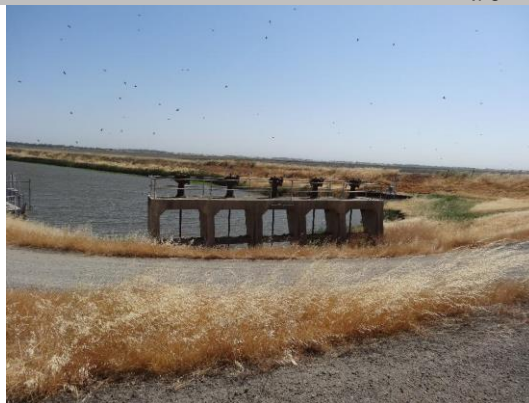
Photo 3 of 3 : UCIP_SP_2019_37611_68222.jpg

Concrete structure visible on landward side.

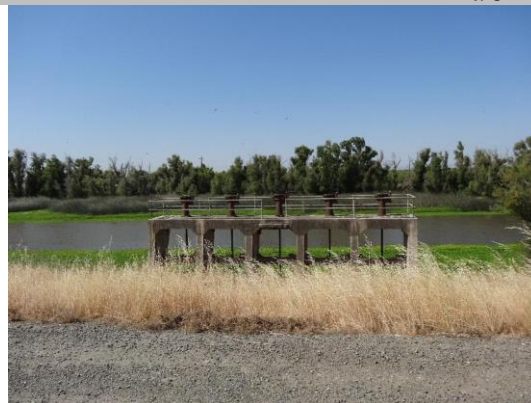
Photo 1 of 3 : UCIP_SP_2019_37607_68203.jpg

Comment Code						
Inspector Comment						
FS_ID:37607 DS_ID:22389 EP_NO: 9396 Repair Type: Non-Urgent Crossing Status: Found UCIP Comments: Need to contact owner to determine status of structure. Notes indicate crossing has been abandoned. Owner will need to coordinate with CVFPB and DWR inspector to determine how to properly abandon. FIELD_STRUCT_DESC: *ABANDONED* 5 of 5: 72-inch reinforced concrete gravity drainage pipe or culvert through the levee, 31.6 feet below the crown. Slide gate on each end. (Retention of five 72-inch pipes through the levee [HLM 0.08] authorized under Automatic Board Order (ABO) issued as Permit No. 9736, 1974 - Reclamation District No. 108 [RD0108]). [Additional Reference(s): DWR Levee Log, 1991. USACE Sacramento O&M Manual 132, October 1959, (HLM 0.08), referenced as five 6-foot by 8-foot concrete drainage culverts]. FS Date: 6/10/2014

Concrete structure located on waterward side.

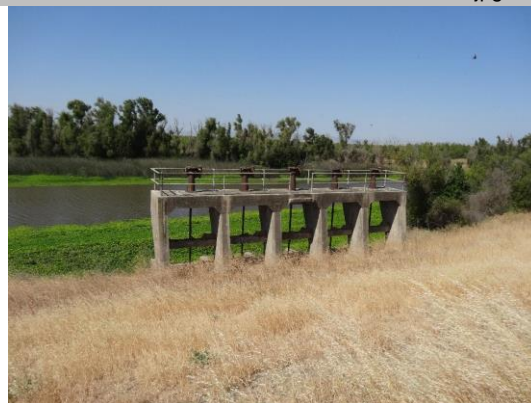
Photo 2 of 3 : UCIP_SP_2019_37607_68206.jpg

Waterward slope covered by dense vegetation.

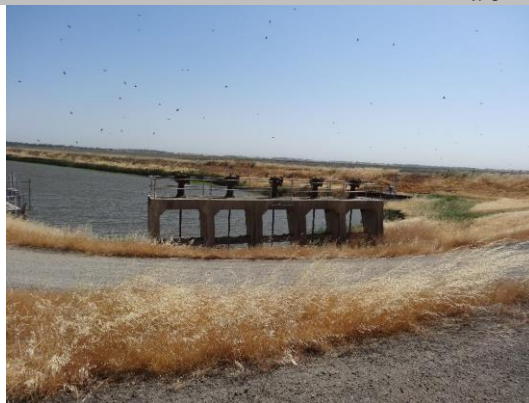
Photo 3 of 3 : UCIP_SP_2019_37607_68204.jpg

Concrete structure located on landward side.

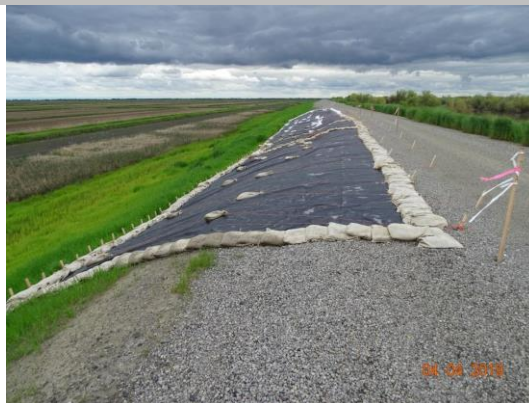
Photo 1 of 1 : SP_2019_RD0108_203_17_20190404_00030.jpg

LM Start	1.49	Rating **	M	Issue No.	17
LM End	1.51	Issue Type +	Ma	Location *	LS
Category	Earthen Levee			GPS Latitude/Longitude	
				Start	End
Item	Slope Stability			38.830951 °	38.831043 °
				-121.821574 °	-121.821847 °
DWR ID	DWR_RD0108_01_s_2019_17				
Comment Code					
S1 : Repair slope instability.					
Inspector Comment					
Sloughing occurred on the landside slope. LMA placed a raincoat over the issue.

View of the sloughing on the landside slope. Spring 2019.

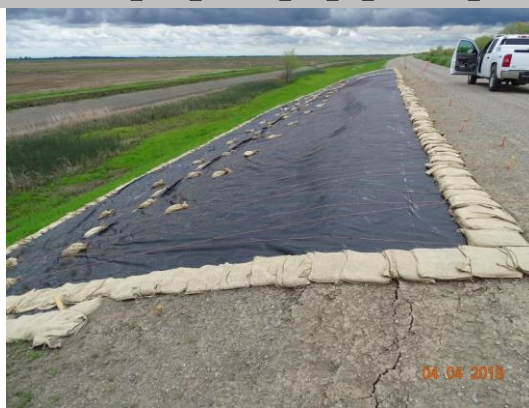
Photo 1 of 1 : SP_2019_RD0108_203_15_20190404_00029.jpg

LM Start	2.72	Rating **	M	Issue No.	15
LM End	2.72	Issue Type +	Ma	Location *	LS
Category	Earthen Levee			GPS Latitude/Longitude	
				Start	End
Item	Slope Stability			38.837714 °	38.837714 °
				-121.842602 °	-121.842602 °
DWR ID	DWR_RD0108_01_s_2019_15				
Comment Code					
S1 : Repair slope instability.					
Inspector Comment					
Sloughing occurred on landside slope. LMA has placed raincoat over the issue.

View of sloughing on the landside slope. Spring 2019.

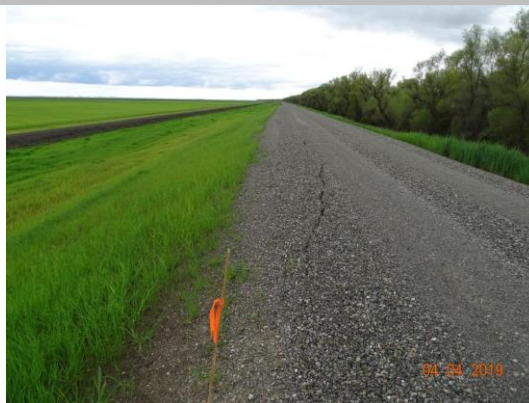
Photo 1 of 1 : SP_2019_RD0108_203_14_20190404_00028.jpg

LM Start	17.30	Rating **	M	Issue No.	14
LM End	17.30	Issue Type +	Ma	Location *	CR
Category	Earthen Levee			GPS Latitude/Longitude	
				Start	End
Item	Cracking			38.995645 °	38.995645 °
				-121.960608 °	-121.960608 °
DWR ID	DWR_RD0108_01_s_2019_14				
Comment Code					
CR2 : Schedule repair of subsidence prior to the next inspection.					
Inspector Comment					
Crown has settled at previous USACE repair site and minor cracking is visible.

View of cracking and settlement on the crown. Spring 2019.

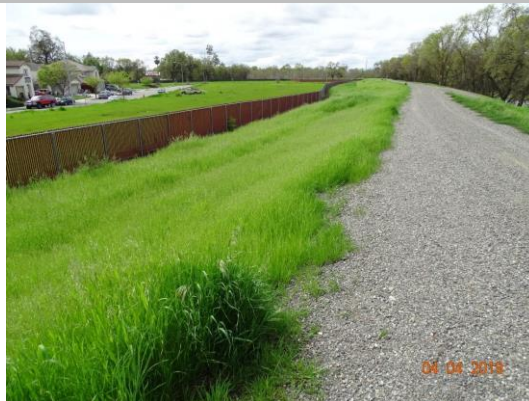
Photo 1 of 1 : SP_2019_RD0108_590_1_20190404_00001.jpg

LM Start	0.04	Rating **	M	Issue No.	1
LM End	0.21	Issue Type +	Ma	Location *	LS
Category	Earthen Levee			GPS Latitude/Longitude	
				Start	End
Item	Vegetation			38.796549 °	38.798393 °
				-121.727329 °	-121.725411 °
DWR ID	DWR_RD0108_02_s_2019_1				
Comment Code					
V1 : Control annual grass and weeds on the levee slopes and easements.					
Inspector Comment

View of vegetation on the landside slope. Spring 2019.
